Home Inspection Report

1000 Palm St., Sampleville, Hawaii 92345

Saturday November 10, 2012

110

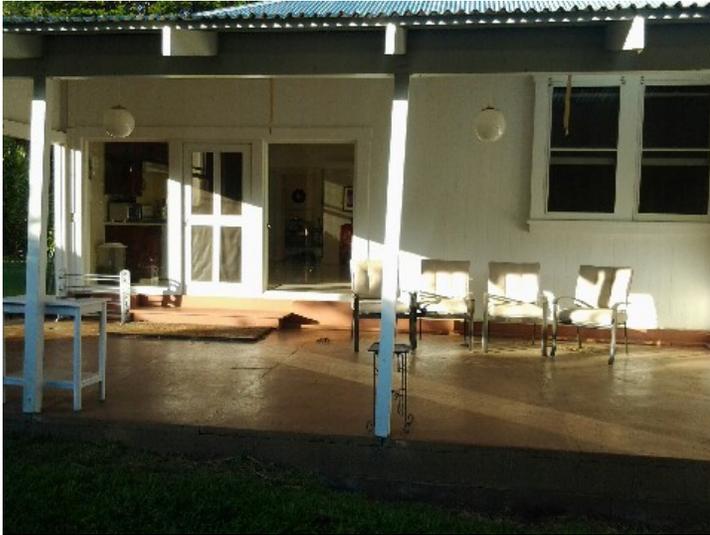
None
Condition Satisfactory Marginal Poor Posts/Supports need Repair Earth to wood contact
 Moisture/Insect damage
Recommend Metal Straps/Bolts/Nails/Flashing Improper attachment to house
Comments Roof support posts all lean due to building shifting in 2006 earthquake. Recommend moving them back to a true vertical position on new postbases.

These roof supports are all leaning (due to the building having shifted during the 2006 earthquake). The condition of these posts does not appear to affect their function but I recommend that at some point in the near future they be restored to a vertical position with new post bases anchored to the concrete.

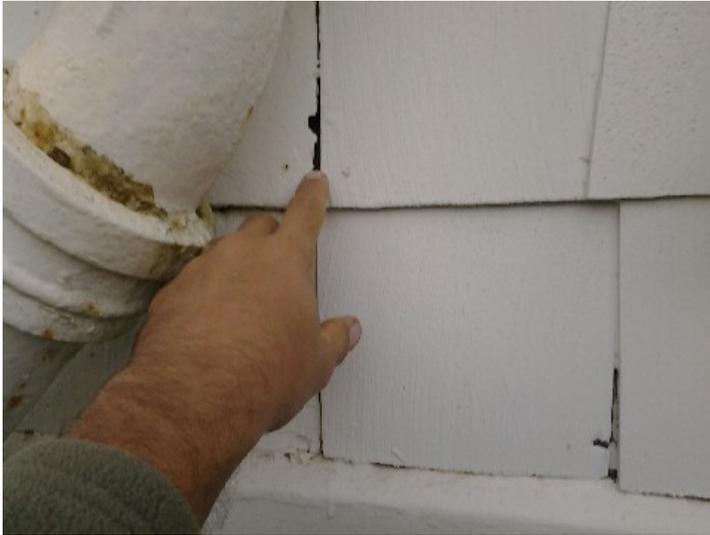
- Material** Stone Slate Block/Brick Fiberboard Fiber-cement Stucco EIFS* Not Inspected
- Asphalt Wood Metal/Vinyl Typical cracks Peeling paint Monitor Wood rot
- Loose/Missing/Holes
- Condition** Satisfactory Marginal Poor Recommend repair/painting
- Comments** Noticed some soft(rotten) areas in the siding and window trim on the east side (see photos)

signs of water penetration and wood rot on the East side.

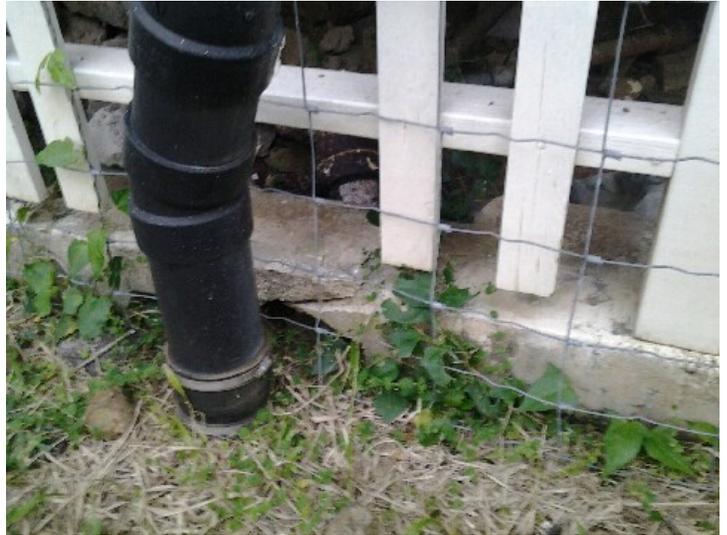
- Foundation Wall** Concrete block Poured concrete Post-Tensioned concrete Not visible
Condition Satisfactory Marginal Monitor Have Evaluated Not Evaluated
Concrete Slab N/A Not visible Satisfactory Marginal Monitor Have Evaluated
Comments There is a section of concrete foundation wall on the east side that shows severe cracking and settling, with noticeable settling in the building structure as well.

Cracked and settling foundation wall- have evaluated.

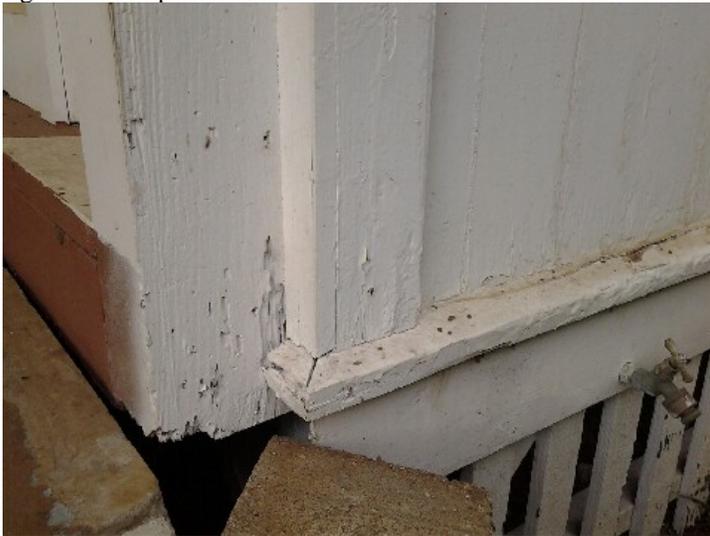
Typical exterior damage consistent with age of the house.

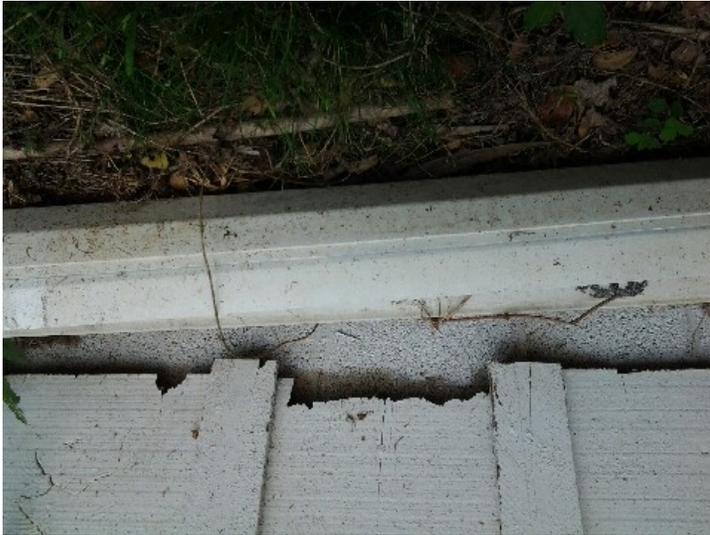
Wood rot at bottom of garage siding.

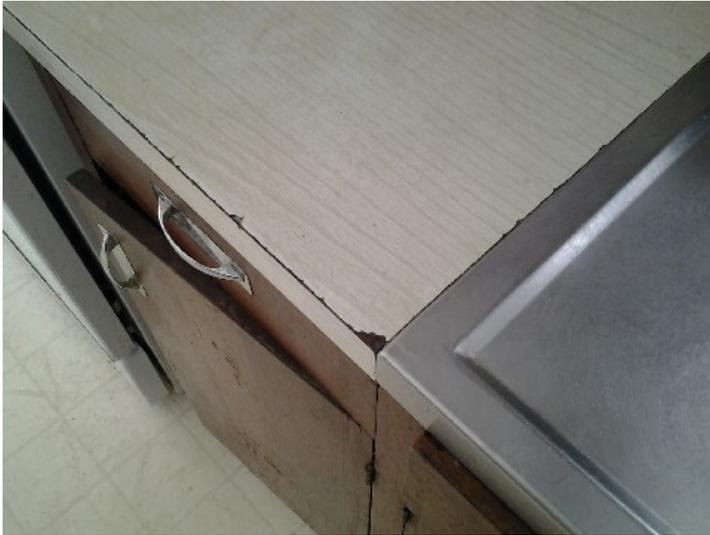
Satisfactory Marginal Recommend repair/caulking
Comments Old formica shows chipping and wear

Counter top wear along edges and corners.

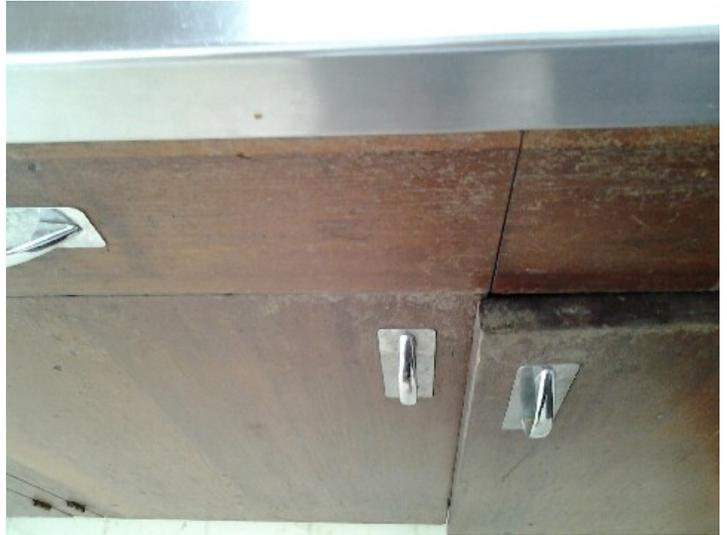
Satisfactory Marginal Recommend repair/adjustment
Comments Doors need adjustments

Cabinet doors need adjustment. These two by the sink were the worst- I could not close them.

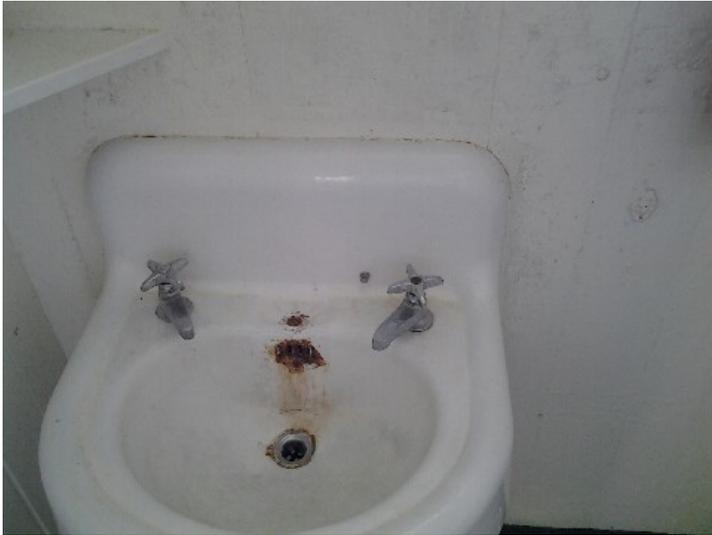
Comments Sink is rusty, mildew on walls

sink rust and mildew

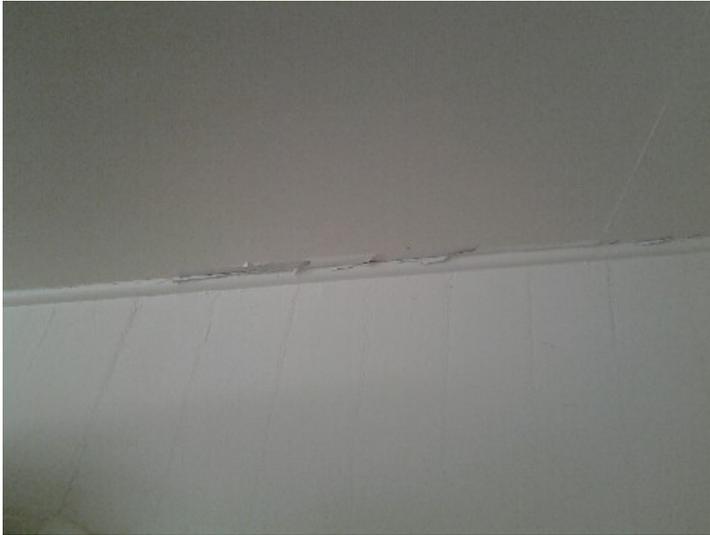
Comments Ceiling has peeling paint and cracks along drywall seams -recommend repair and repaint

peeling ceiling paint

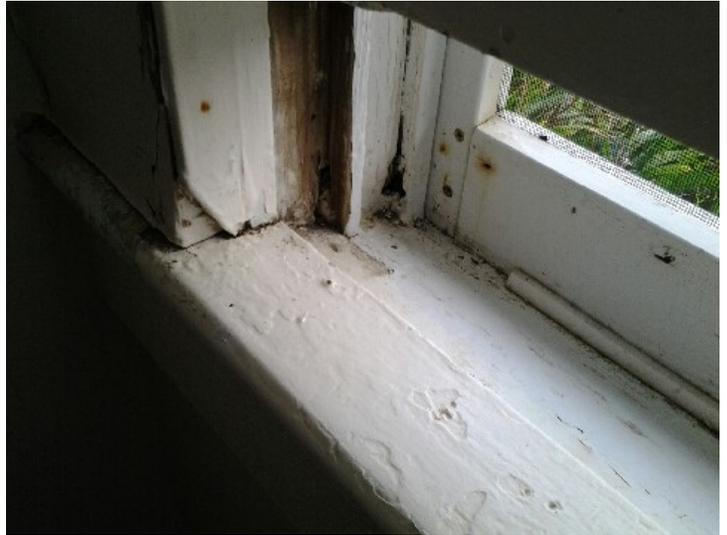
wood rot at corner of window

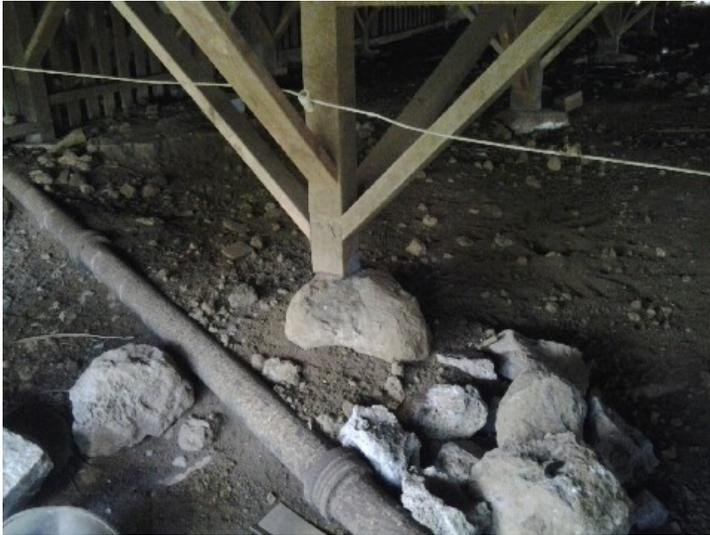
Post no longer rests on center of pier. I recommend pier be moved back under center of post.

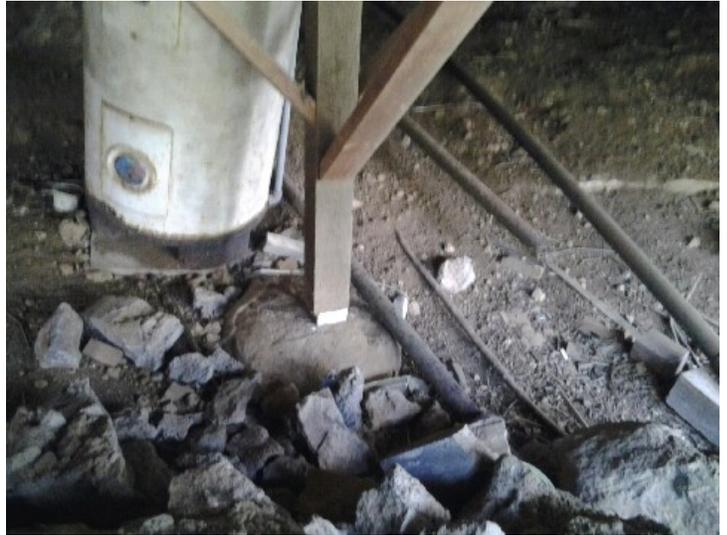
Post with a small block of wood as a shim. Either a new longer post should be installed or the shim block should be secured by gussets on all four sides.
